# **ALTERNATIVES ANALYSIS REPORT**

## **LORENZAN CREEK STORMWATER IMPROVEMENT PROJECT**

**Prepared for  
Skagit County Public Works  
1800 Continental Place  
Mount Vernon, Washington 98273**

**Prepared by  
Herrera Environmental Consultants, Inc.  
1329 North State Street, Suite 200  
Bellingham, Washington 98225  
Telephone: 360-398-5075**

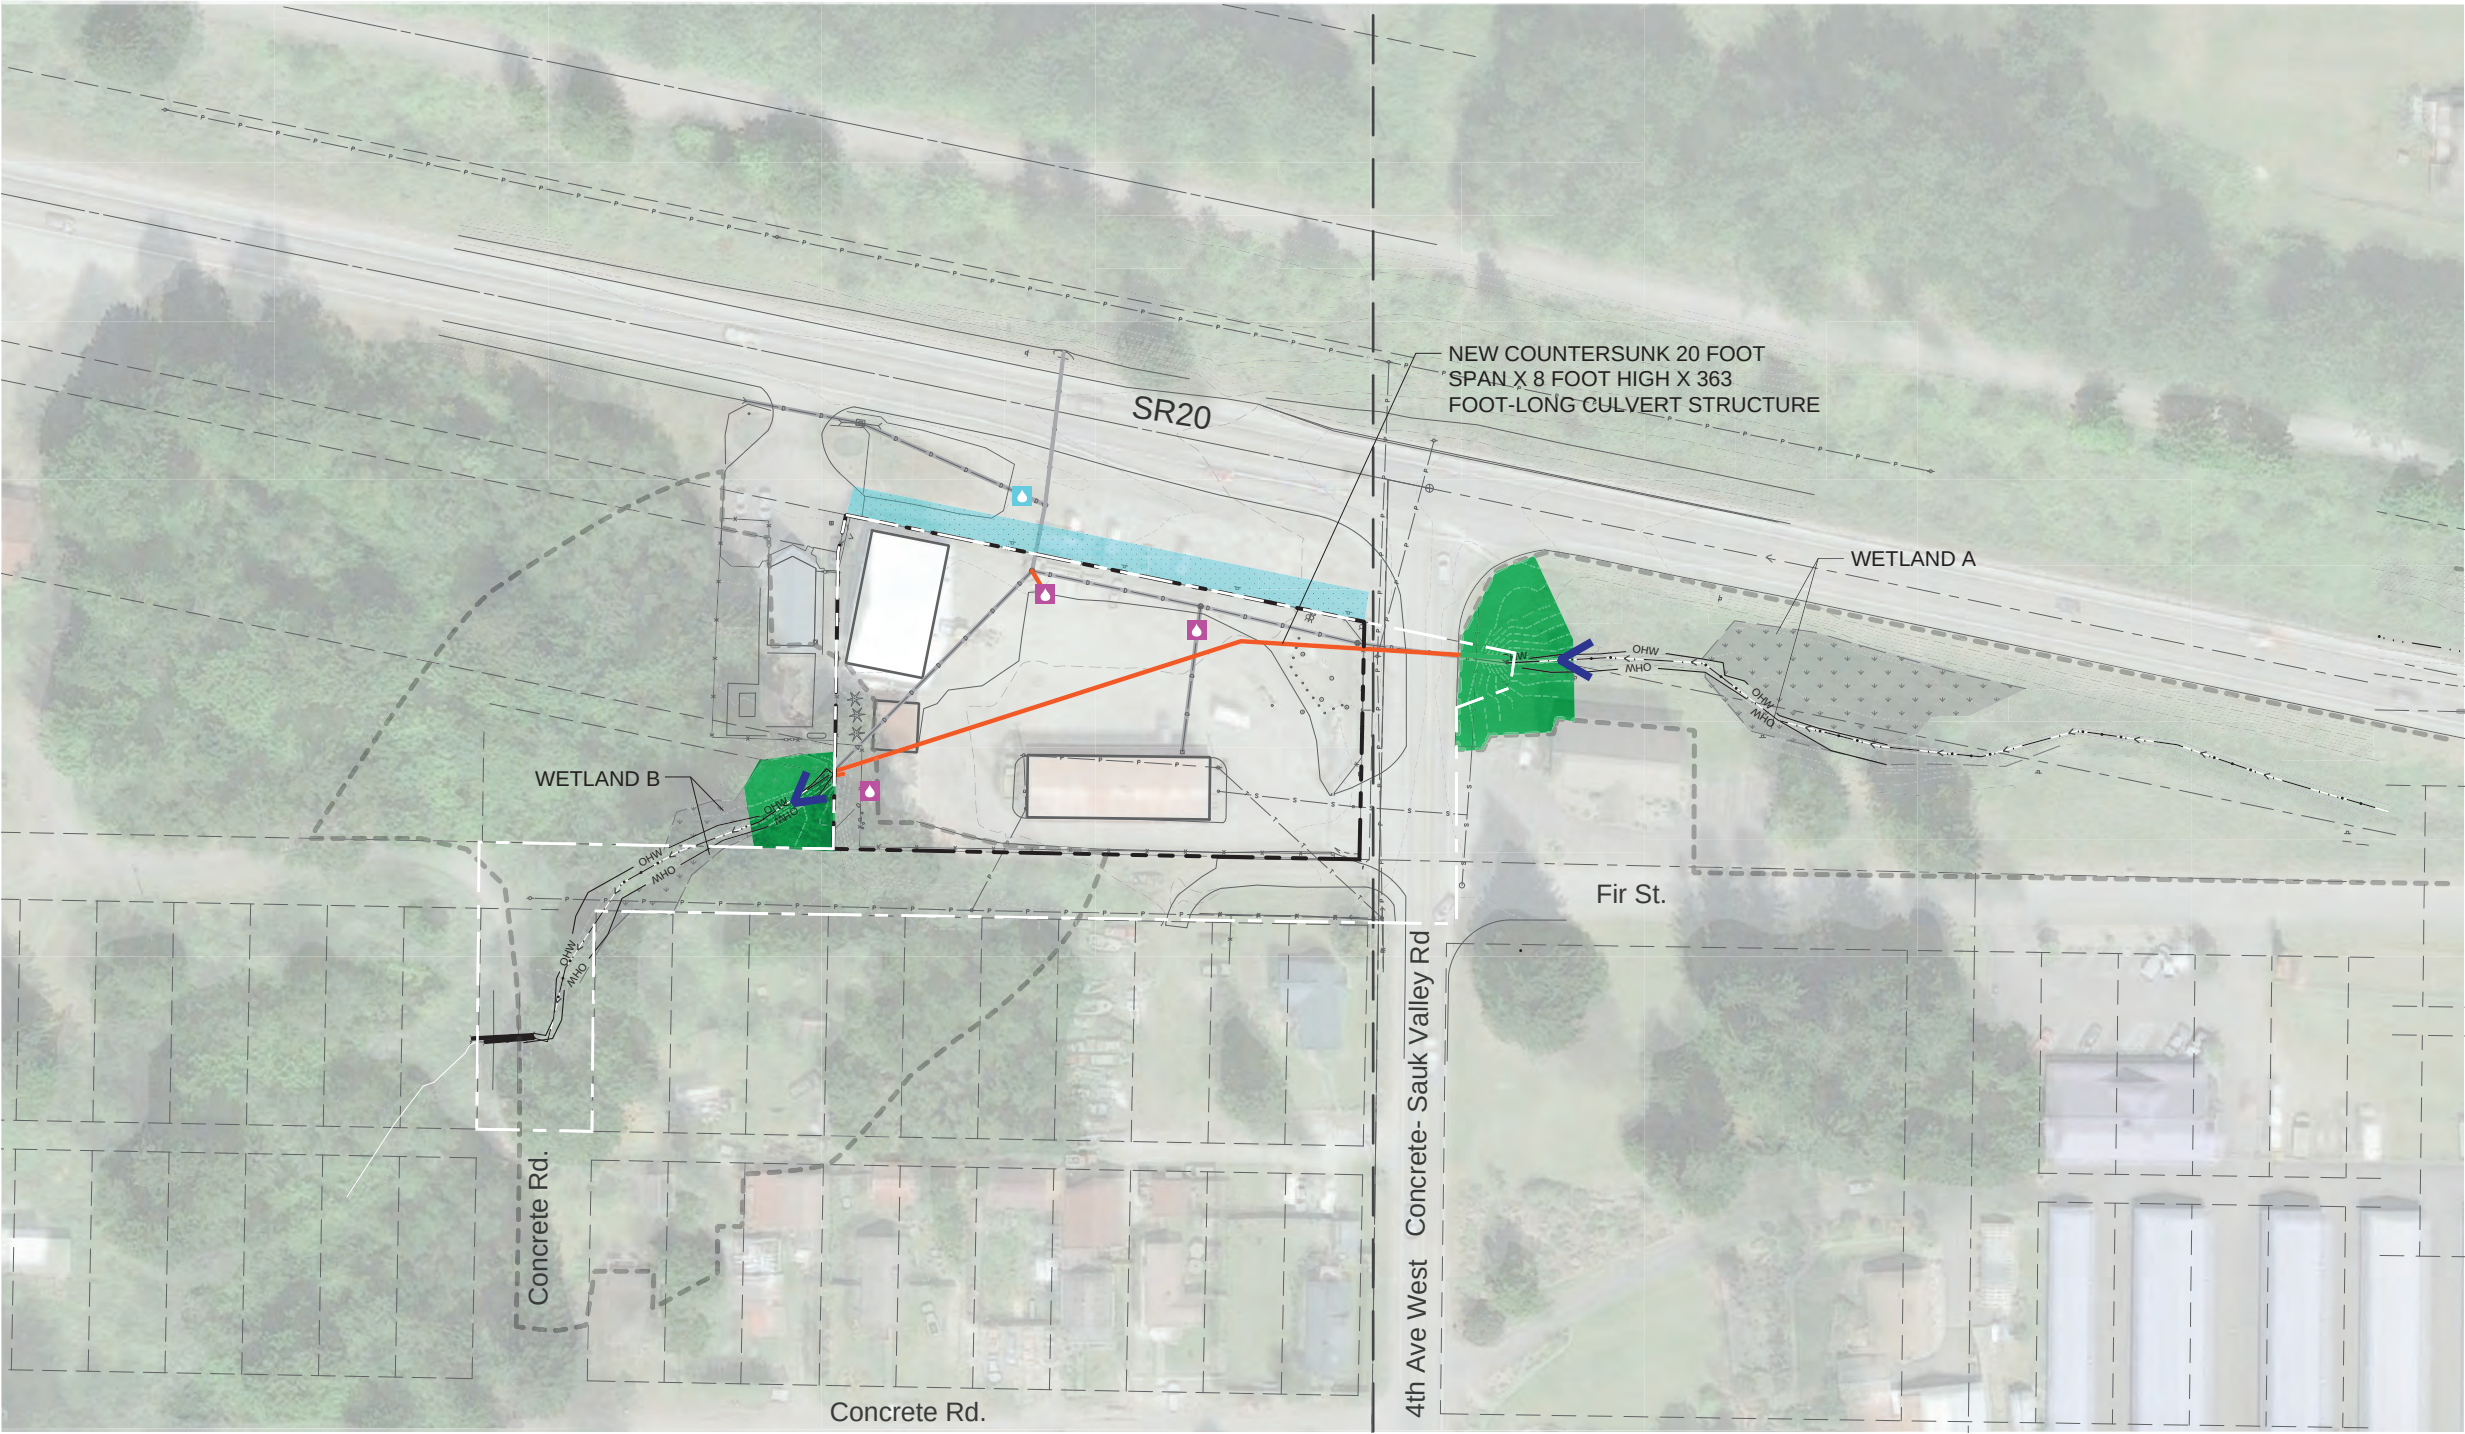
FIGURE 2.  
Alternative 1 Conceptual Site Plan

areas temporarily disturbed during construction would be restored. Figure 2 shows a conceptual site plan of the Alternative 1 improvements. Figure 2 also shows recommendations for the addition of a media filter drain (MFD) and water quality treatment device in the SR 20 right-of-way (ROW) to be considered for design and installation by the Washington State Department of Transportation (WSDOT) for further water quality treatment, but the costs and performance of these elements are not included in this analysis.

Conservatively using a maximum bankfull width of 11 feet as measured in upstream reaches of Lorenzan Creek (Appendix A), and following a stream simulation approach for culvert span sizing (Equation 3.2 in WDFW 2013), the proposed structure would need to be 16 feet wide. The WDFW Fish Passage Design Guidelines (2013) also recommend increasing the culvert span by an additional 30 percent for long culverts such as this one. As a result, the total recommended span for the replacement culvert is 20 feet. The proposed culvert alignment requires a bend to avoid excavation below County shop structures expected to remain. Any stream and wetland buffer
